[Pennsylvania Drought Condition Monitoring - Tuesday, May 26, 2026](#)

### Groundwater

### Streamflow

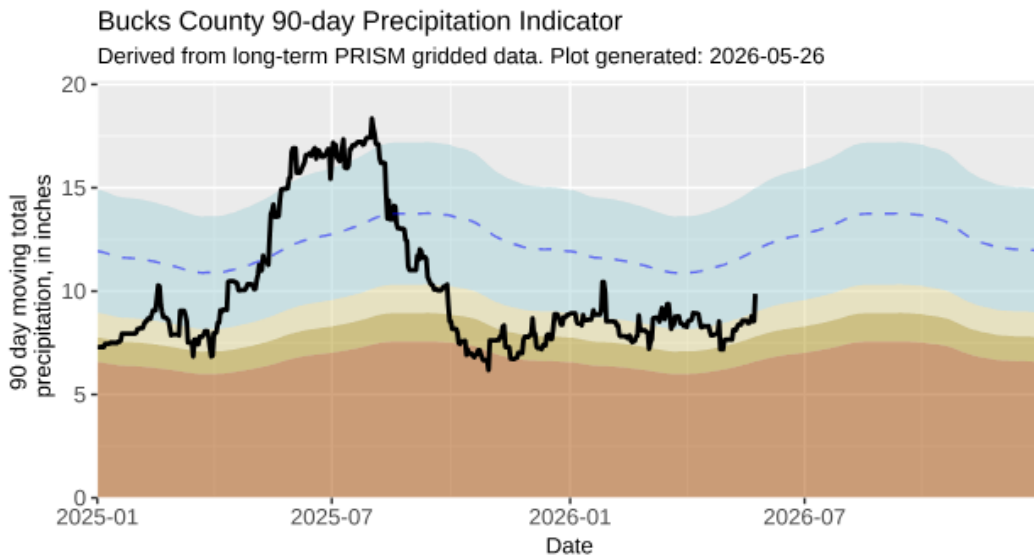
After recent rainfall, the 90-day Precipitation Indicator is now in normal status. Over the past 90 days (2/25 – 5/26), 9.9 inches of precipitation fell over Bucks County. The average 90-day precipitation is 12.0 inches. Winter precipitation is most effective for aquifer replenishment.

Over the past 365 days, 37.8 inches fell over Bucks County which is just within the normal range (the average is 50.1 inches).

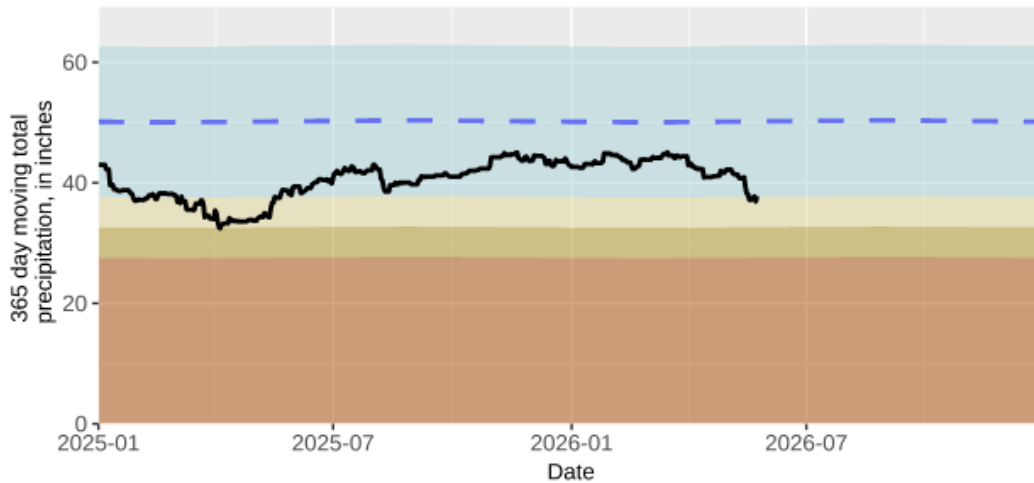
### Bucks County 365-day Precipitation Indicator

Derived from long-term PRISM gridded data. Plot generated: 2026-05-26

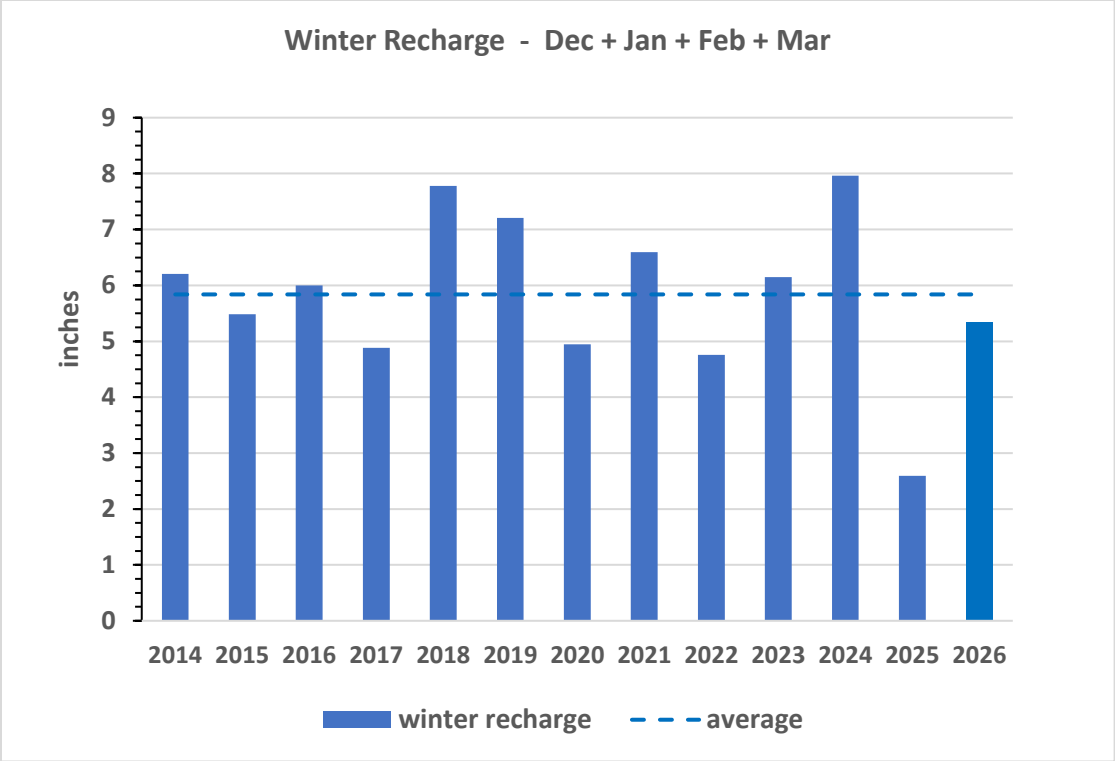
Recharge occurring over the winter months (December through March) accounts for, on average, 5.8 inches of 9.9 inches (59%) of annual average recharge (Hydrologic Budgets and Seasonal Trends - Tohickon Creek Watershed, Baehr, January 22, 2026). The plot below provides a comparison of this past winter's recharge to previous years. The value of 5.3 inches is slightly below the 5.8 inches average, therefore, average water levels are likely to occur in upcoming months.

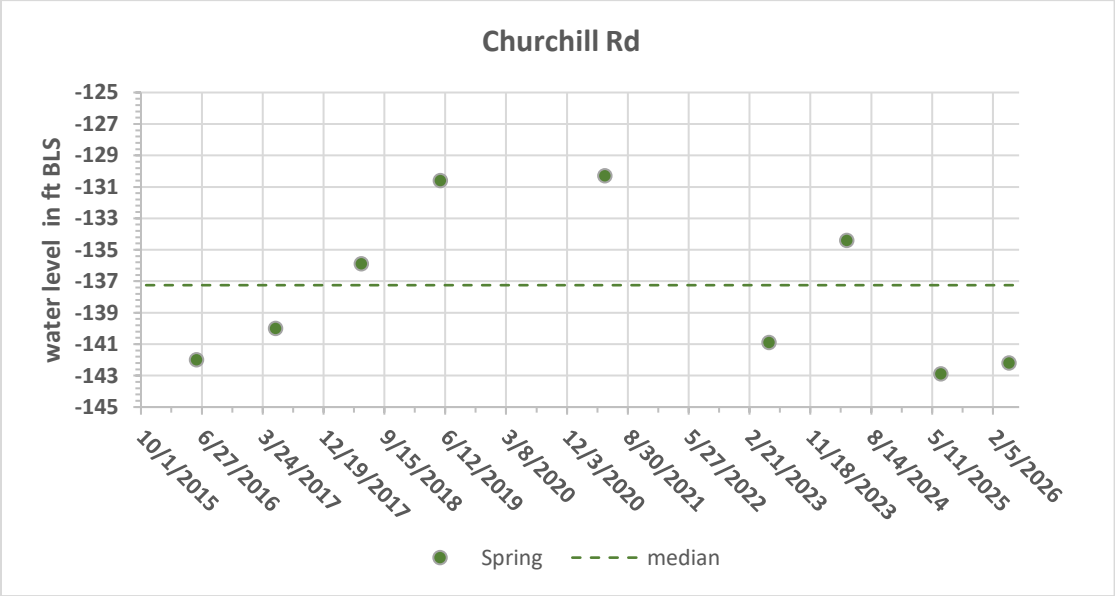
Nockamixon SWL 14 wells

Spring water level values are provided in the graphs below. Water-level data was collected for the Spring 2026 synoptic from 4/17 to 5/7 at the Nockamixon SWL wells and on 5/19 for the Tinicum and Bridgeton SWL wells. The Spring SWL synoptics are intended to measure the yearly high water levels, however, the exact date that the high values occur can not be predicted a priori. For reference, the water level at USGS well 1020 at Warminster achieved the seasonal high on 3/28/2026 and as illustrated below has a current water level in the watch category. Drought categories for this well are based on data dating back to 1975. Well 1020 is situated in the Stockton formation.

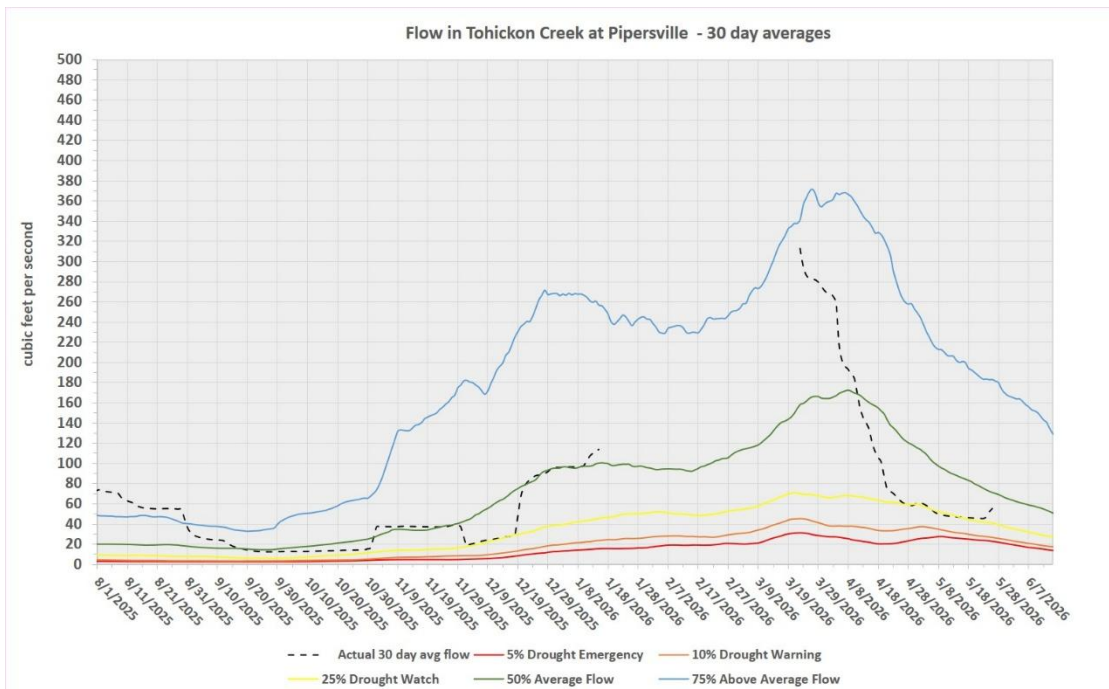
The 30-day average flow is now in the normal category.
